# **Dam Safety Assessment of CCW Impoundments**

## **Kincaid Generation – Slag Field**

**United States Environmental Protection Agency  
Washington, DC**

March 24, 2011

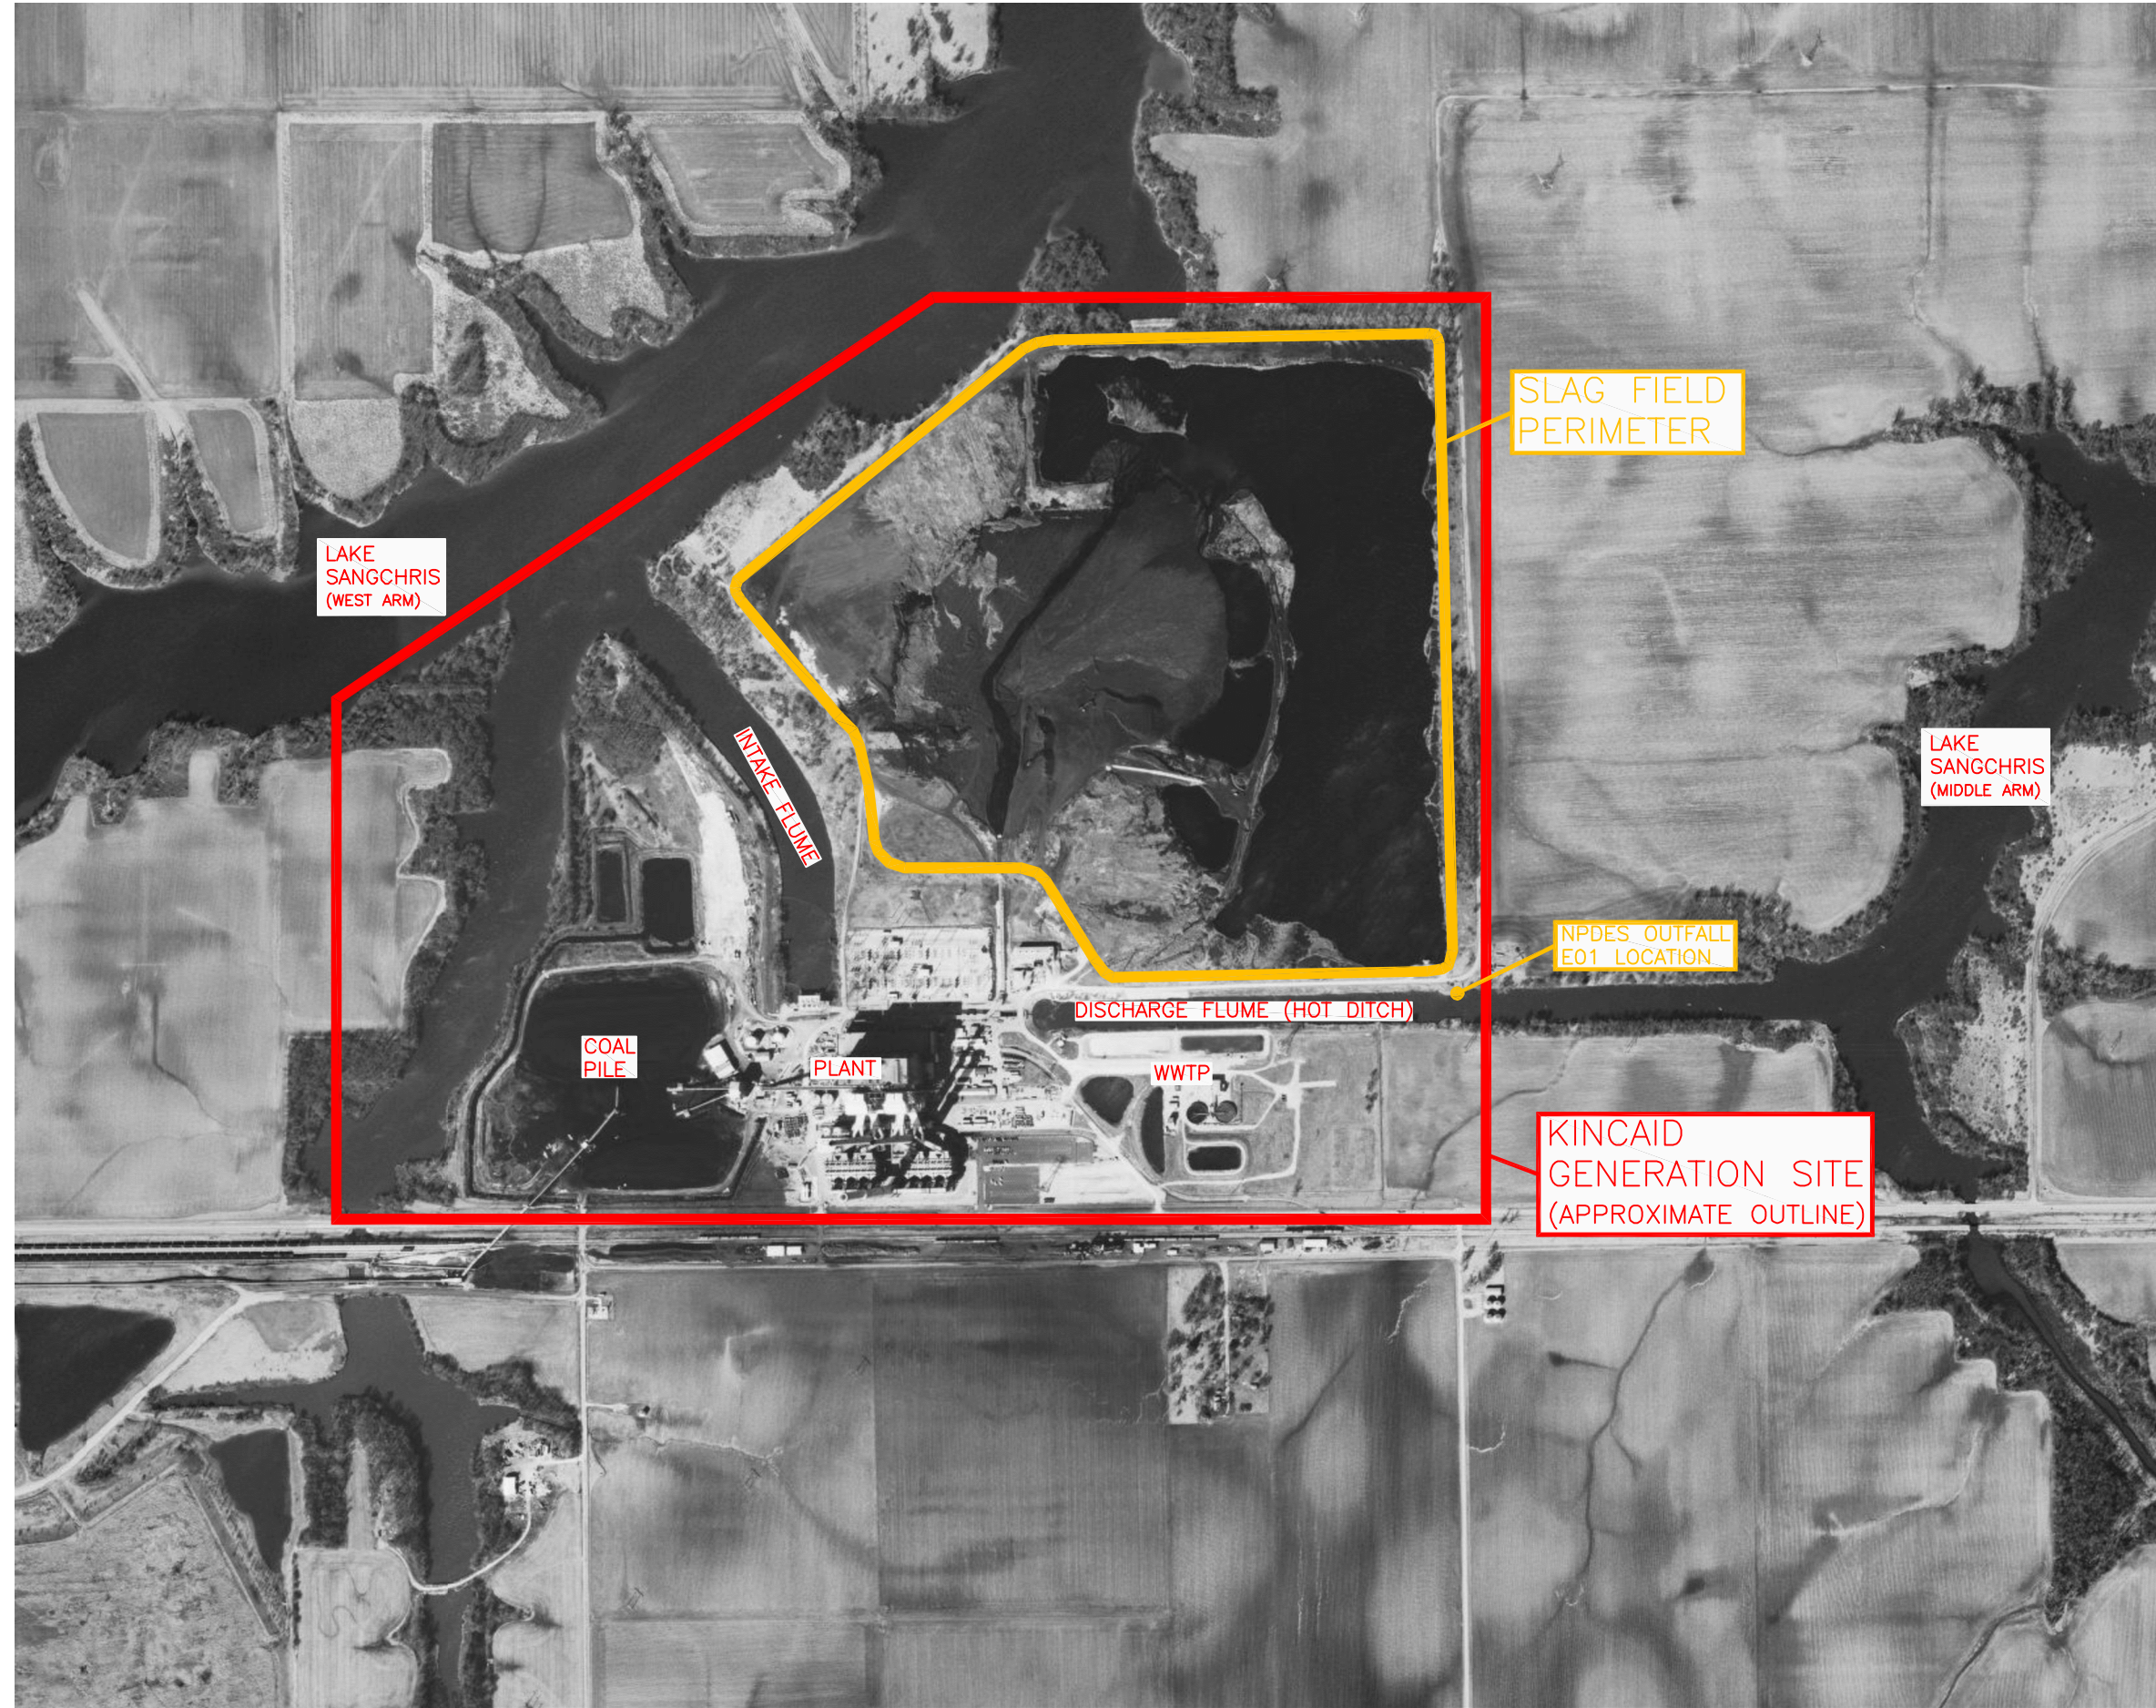
FIGURE 2

1. EROSION OBSERVED ON DOWNSTREAM SLOPE
2. MINOR GULLY EROSION OBSERVED AT CREST AND ON DOWNSTREAM SLOPE
3. WET AREA OBSERVED NEAR TOE, FACILITY PERSONNEL REPORTED THAT DRAIN TILES FROM ADJACENT FARMLAND DAYLIGHTS NEAR THIS AREA
4. EXISTING LARGE TREE STUMPS OBSERVED
5. RIP-RAP PLACEMENT PROJECT OBSERVED IN PROGRESS, SOME RIP-RAP PLACEMENT AND MINOR GRADING TO BE COMPLETED
6. STUMP REMNANTS AND WOODY DEBRIS OBSERVED ALONG THE EAST EMBANKMENT, SLOPE SURFACE IN NEED OF REGRADING AND VEGETATION REESTABLISHMENT

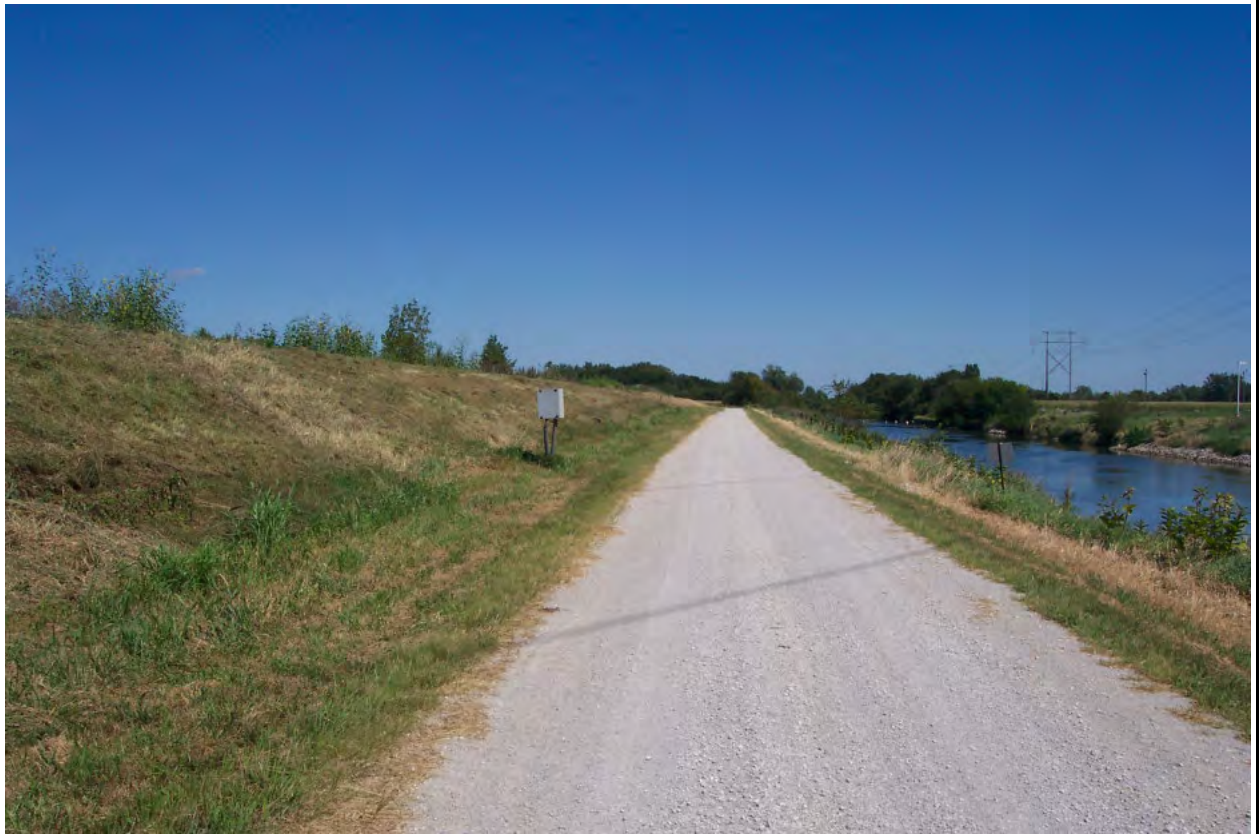
Photo Number:  
1

Description:  
View along  
access road at  
toe of east  
portion of south  
embankment,  
Discharge  
Flume (Hot  
Ditch) at right.

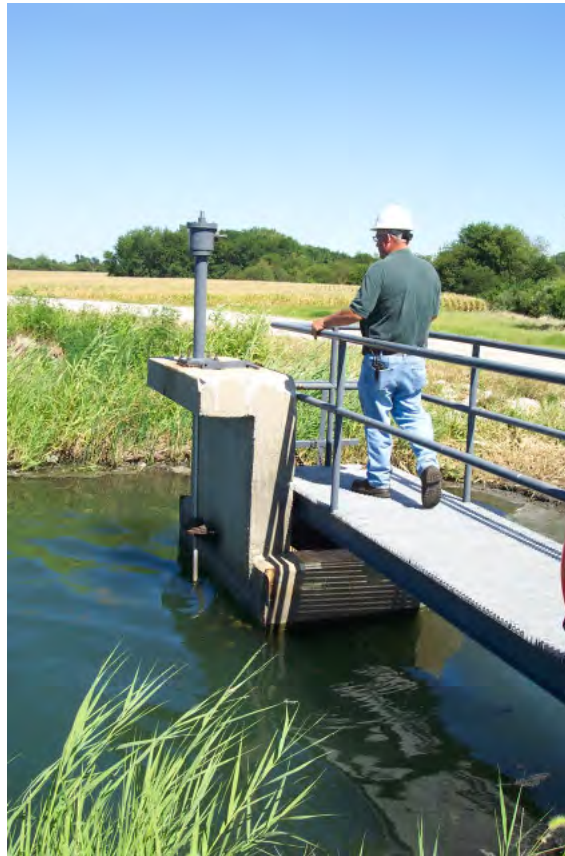
Photo Number:  
3

Description:  
View of  
emergency  
overflow  
structure and  
emergency  
valve stem and  
actuator

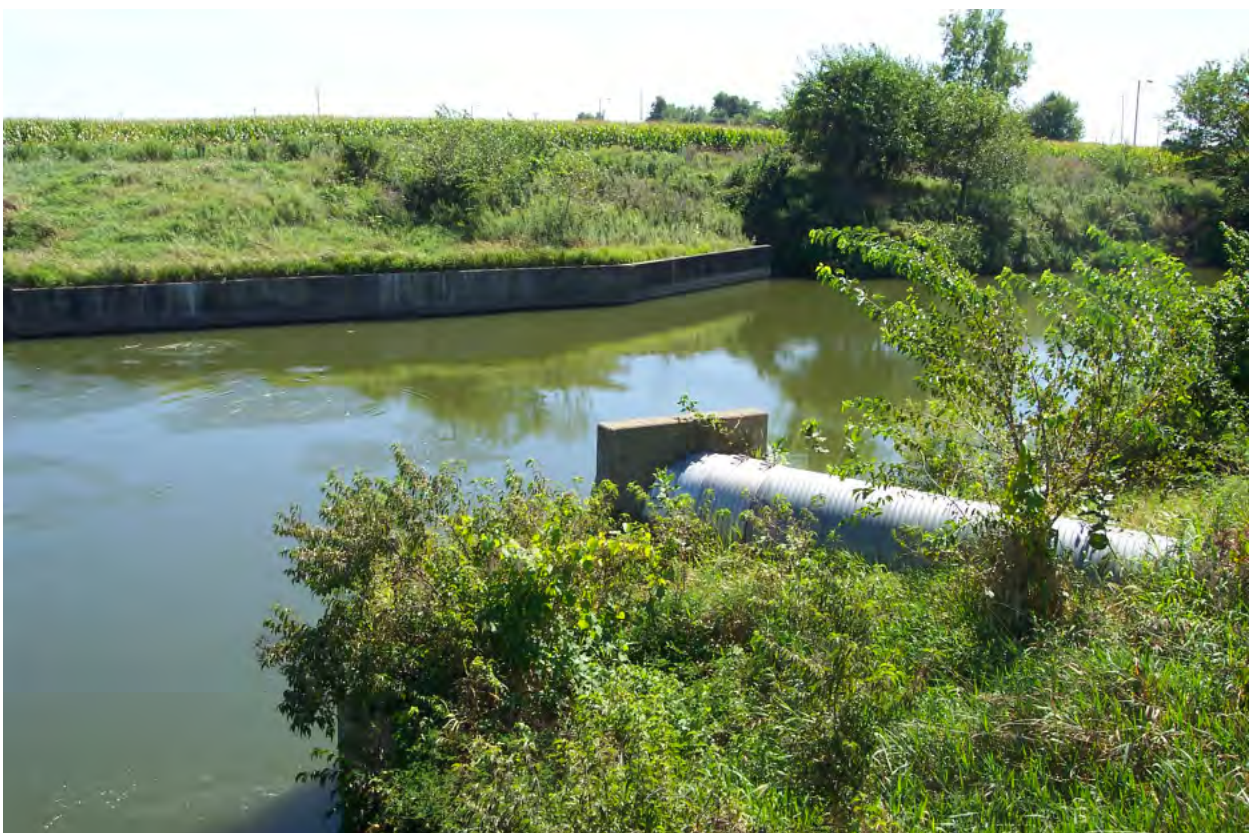
Photo Number:  
4

Description:  
View of  
emergency  
overflow outlet  
into "hot ditch"  
(NPDES Outfall  
'E01')

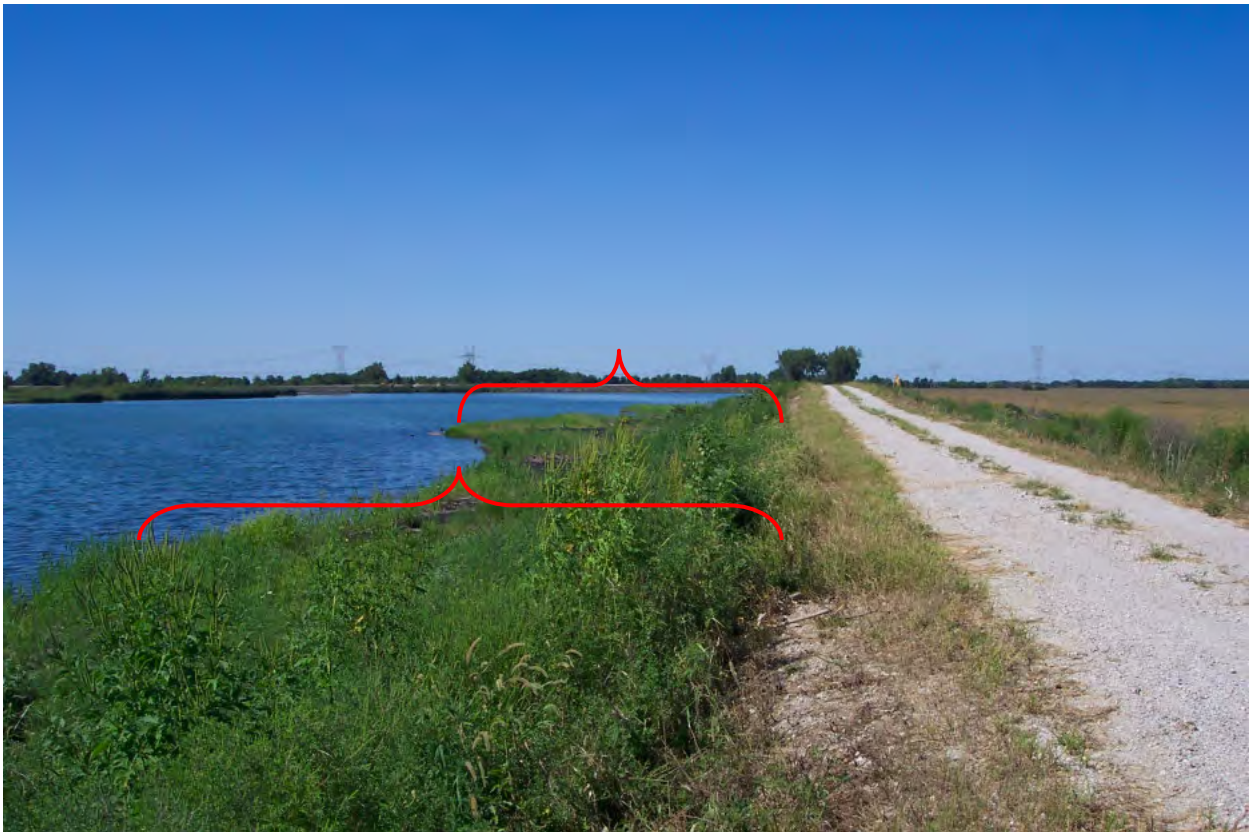
Photo Number:  
6

- The screen house and recycle pumping operation was added in the late 1970's (Appendix B – Photo 2)
- The impoundment was dredged in the mid 1980's with dredged slag placed along interior slopes of portions of the impoundment perimeter. Under the current operation, this deposited slag is essentially a permanent feature. (Appendix B – Photos 6 & 9)

Description:  
View along  
crest of east  
embankment

Note  
“permanent”  
areas of slag on  
interior side of  
embankment

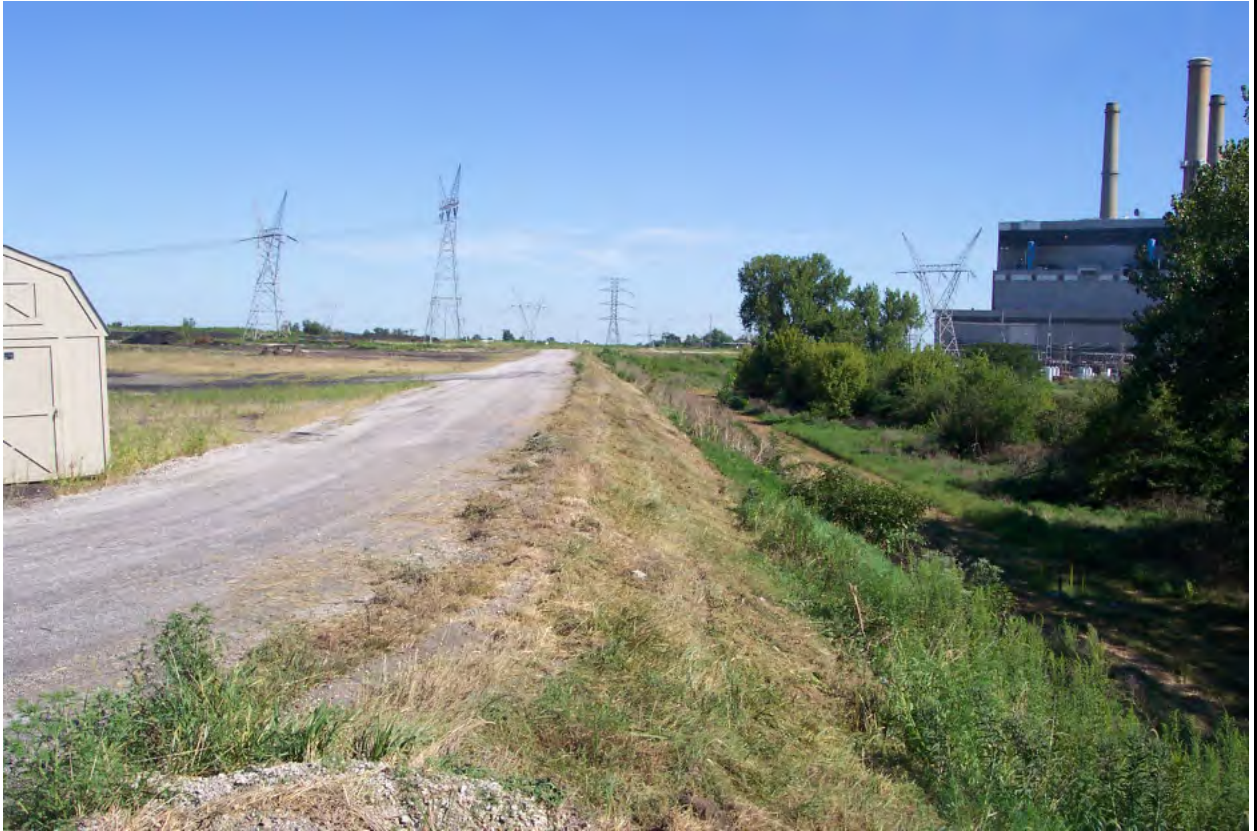
Photo Number:  
15

Description:  
View along  
crest of  
southwest  
embankment

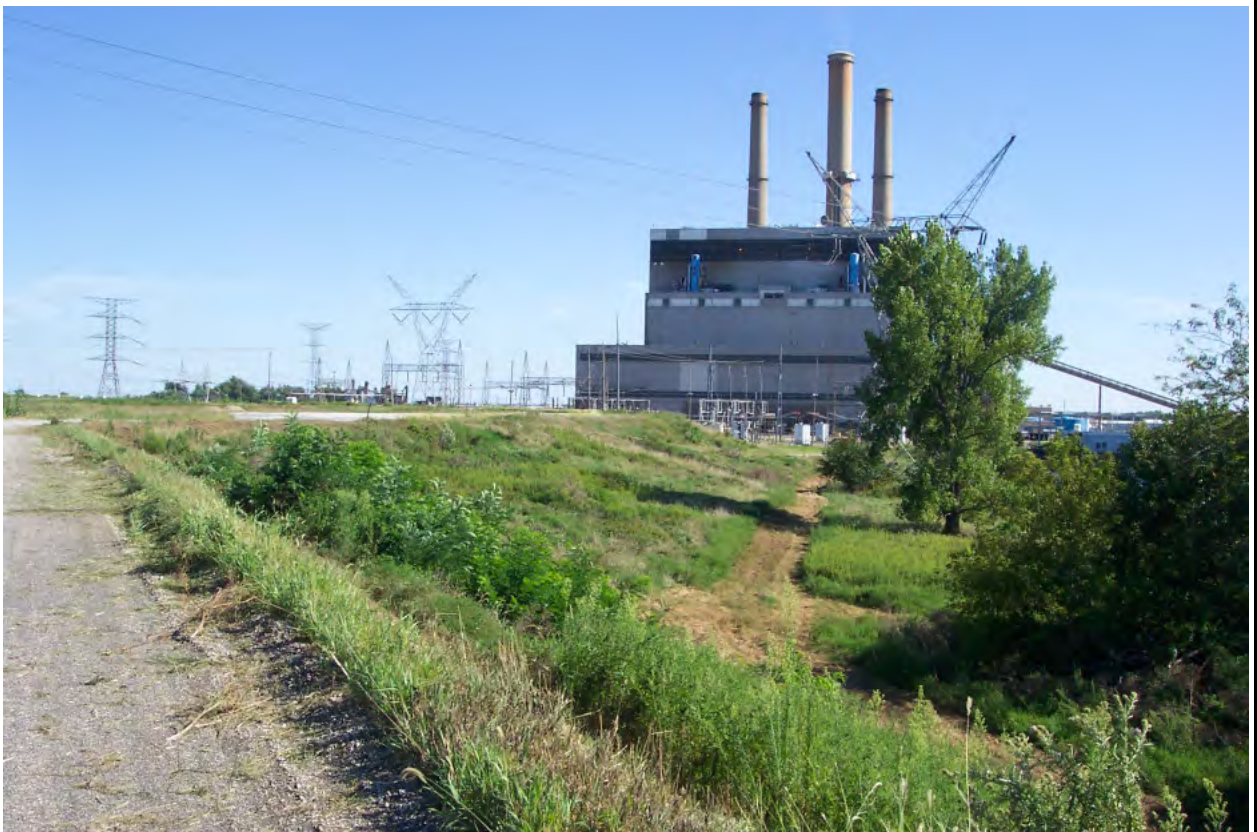
Photo Number:  
16

Description:  
View along west  
embankment

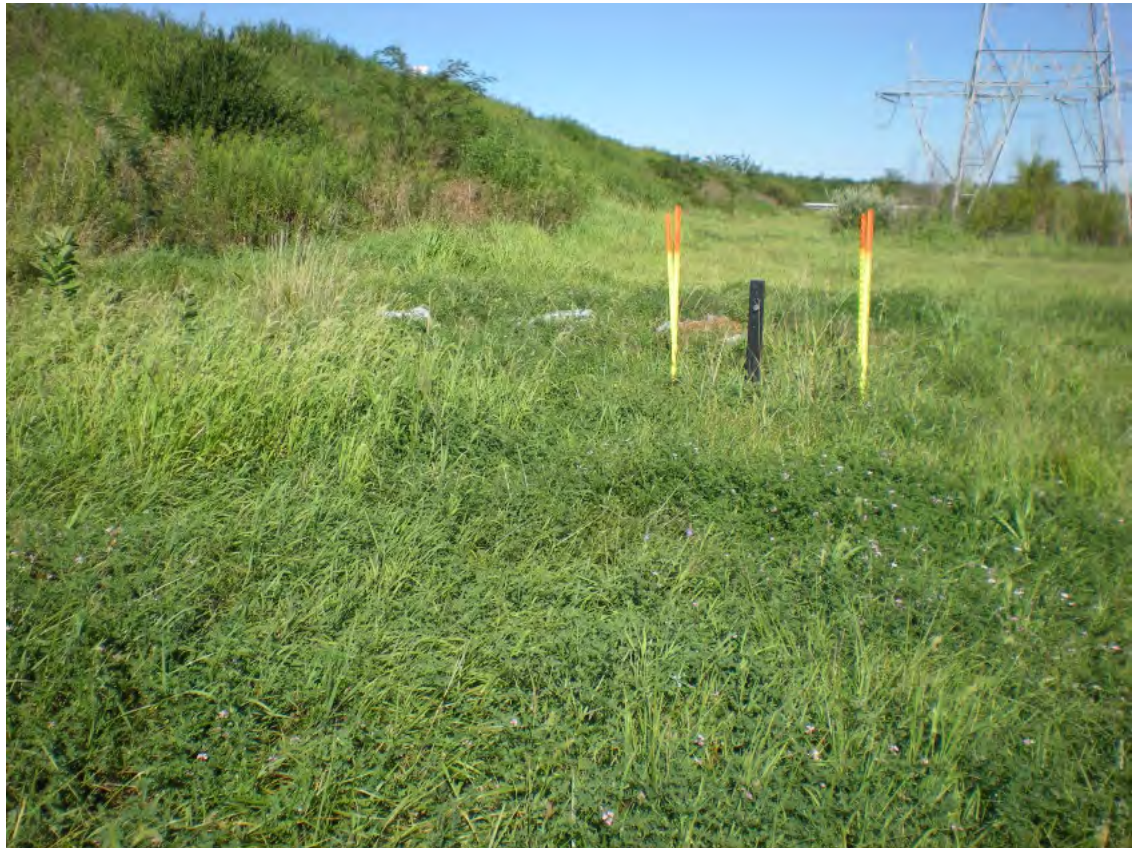
Photo Number:  
17

Description:  
View of eroded  
slope from toe  
on west portion  
of south  
embankment

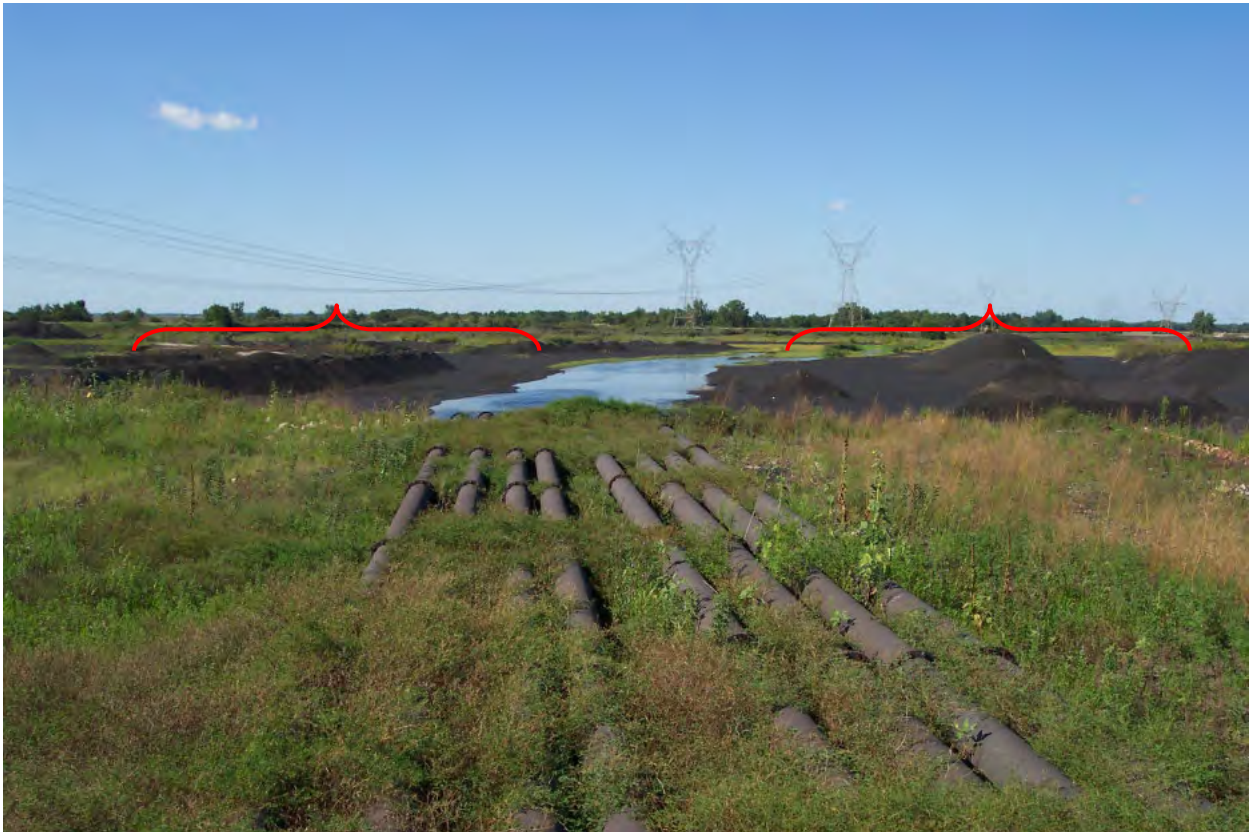
Photo Number:  
19

Description:  
View along  
discharge piping  
into slag field.

Note contracted  
recycling  
company's slag  
recovery  
piles/staging  
area along sides  
of inlet  
waterway
